# Manhole Inspection Summary

Manhole # S19E1\_005MH

**Location** Address: **ATLANTIC AVE**

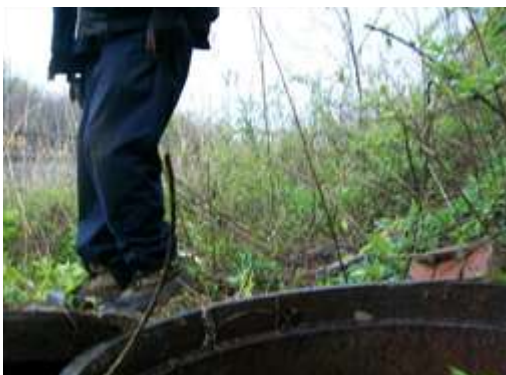
Location View

ADJACENT TO RR TRACKS - NO  
STRUCTURES AVAILABLE FOR  
LOCATION VIEW

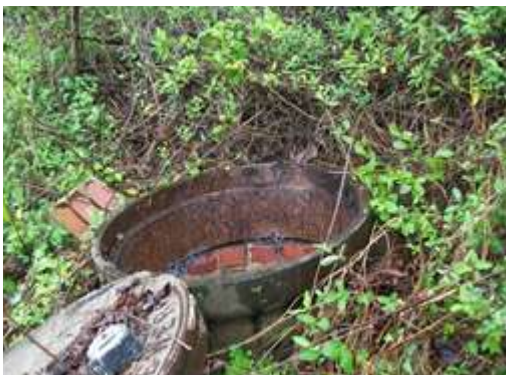
Miscellaneous

**Cover** Shape: **Circular** Diameter: **24** (in.) Length: **0** (in.) Dist A/B Grade: **6** (in.)

6" ABOVE GRADE

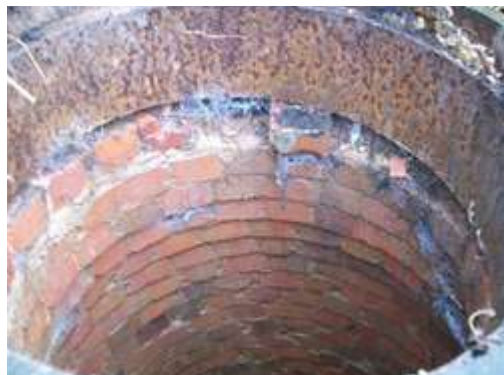
Defect 3

Condition: ☐ Sound ☒ **Cracked** ☒ **Root Intrusion** ☒ **Loose Brick** ☒ **Deteriorated**

ROOT INTRUSION AT  
CHIMNEY/FRAME JOINT

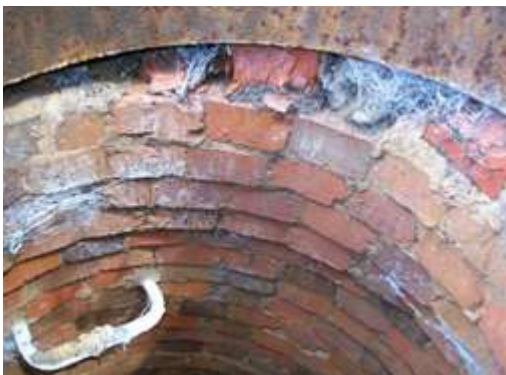
Defect 2

DETERIORATED, CRACKED, AND  
LOOSE BRICKS IN CHIMNEY

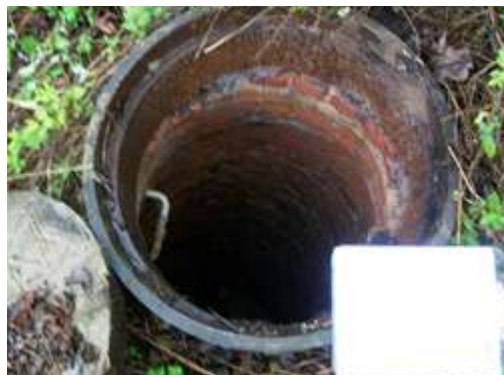
Defect 1

**Frame** Offset: **1.5** (in.) Condition: ☒ Sound ☐ Cracked ☐ Leaks

FRAME OFFSET 1.5"

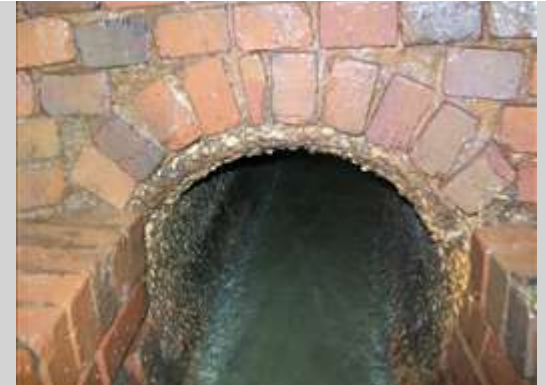
12 O'Clock Outflow

18 in. Circular Gravity Sewer  
Pipe Out @ 12 O'Clock

Invert Depth: **14.78** (ft.) Flow Characteristics: **Fast**

Infiltration: **None** Pipe Seal Cond: **Sound**

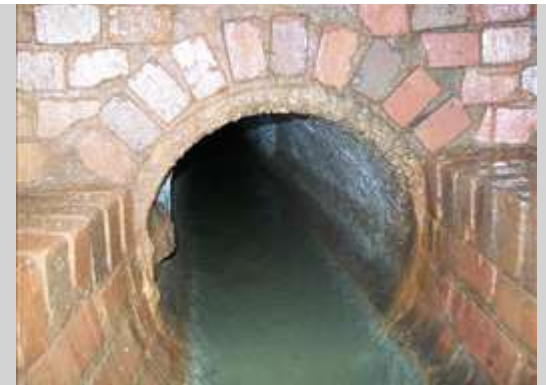
6 O'Clock Inflow

18 in. Circular Gravity Sewer  
Pipe In @ 6 O'Clock

Invert Depth: **14.58** (ft.) Flow Characteristics: **Fast**

Infiltration: **None** Pipe Seal Cond: **Sound**
